FLYER TO COMMERCIAL VESSELS

TRIDENT V: Collision with Cambridge Berth, St Peter Port **24th August 2014**

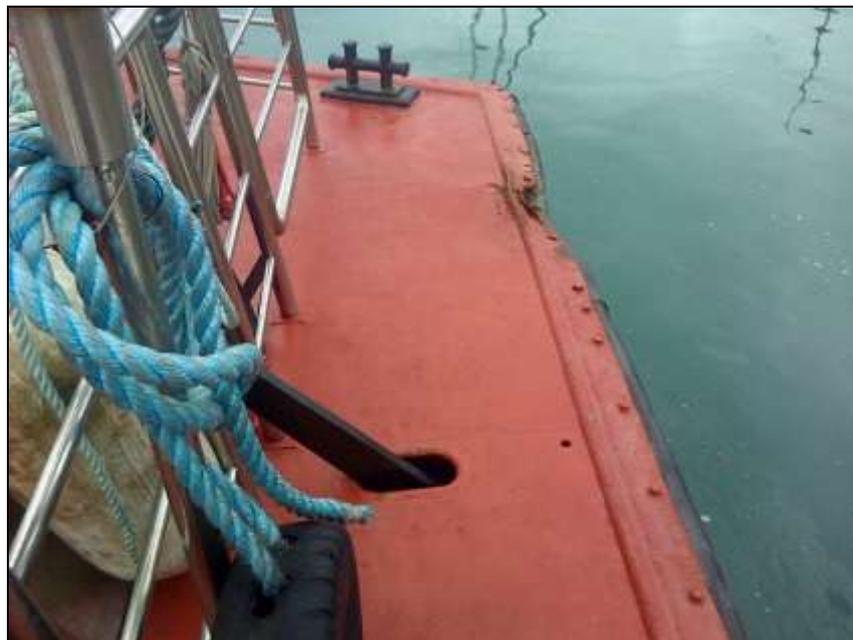
Damage to the forward athwartships deck and belting was sustained at the port bow area (see figure 2).

Figure 2: Contact damage to forward deck

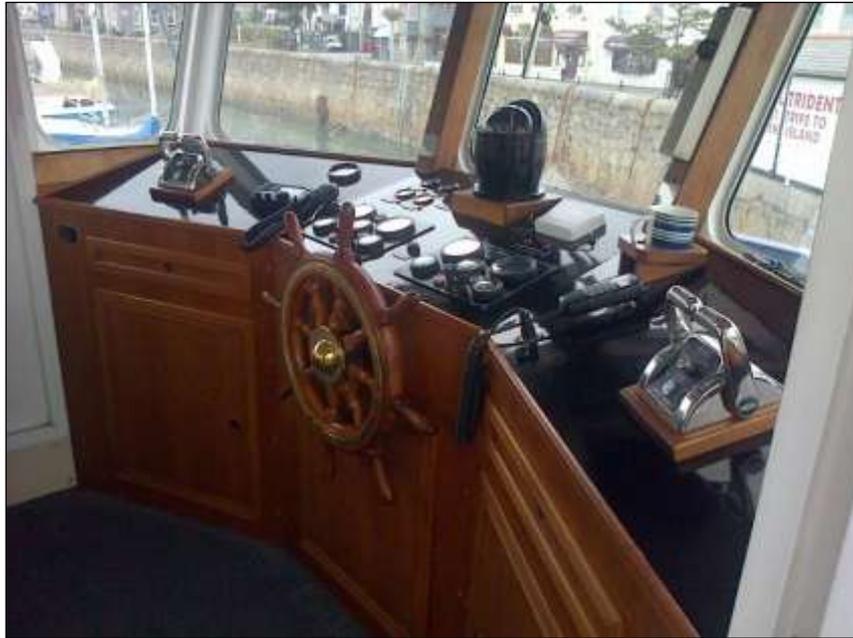
Figure 3: TRIDENT V wheelhouse arrangement

As the tide was falling, the crew requested that the Master move the vessel astern to re-align the deck with the steps. The Master went to the port engine controls to apply astern propulsion and realised that there was still no response when he applied additional revolutions. This is when he noticed that the controls were set in 'troll' mode, not 'cruise' (see figure 4). The Master immediately recognised the setting was incorrect and switched the controls to 'cruise' when he instantly had full control again.

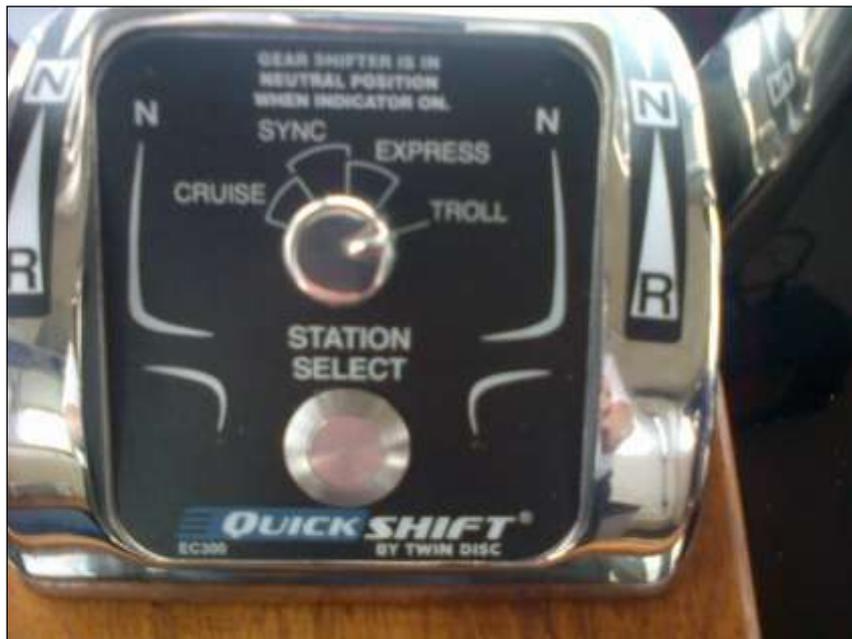
Figure 4: EC300 Marine Control System

'Troll' mode is designed to allow the engines to be operated at very low speed and prevents increase in revolutions if the lever setting is increased. It is particularly useful for this particular operation when the vessel is motoring on a spring rope to keep the vessel firmly alongside during passenger operations as it assists in reducing thrust and wash, which can affect other vessels in the immediate vicinity.

1. The collision occurred as a result of the main engine control system on the port side of the wheelhouse being operated in 'troll' mode without the Master realising so. This limited the available propulsion power to fully control the vessel during its approach to the Cambridge Steps.

2. Prior to the accident, no formal procedure was in place for the Master and crew to 'cross check' the engine control system settings prior to the requirement to manoeuvre in confined areas.

3. The operator has introduced a procedure prohibiting the use of 'troll' mode.
4. The operator has introduced a procedure for the Engineer to 'cross check' the engine control settings are in 'cruise' mode prior to the vessel entering harbours or areas with restricted sea-room.

5. Consideration should be given to the appropriate stage within the passage plan to change between control positions and carryout a function test to ensure full control is available. This should be carried out before the point of no return when an abortive manoeuvre remains possible.
