FLYER TO FISHING VESSELS AND SMALL CRAFT
GU33 LADY HELEN – S: Engine Room Explosion, St Helier
17th June 2014

July 2014

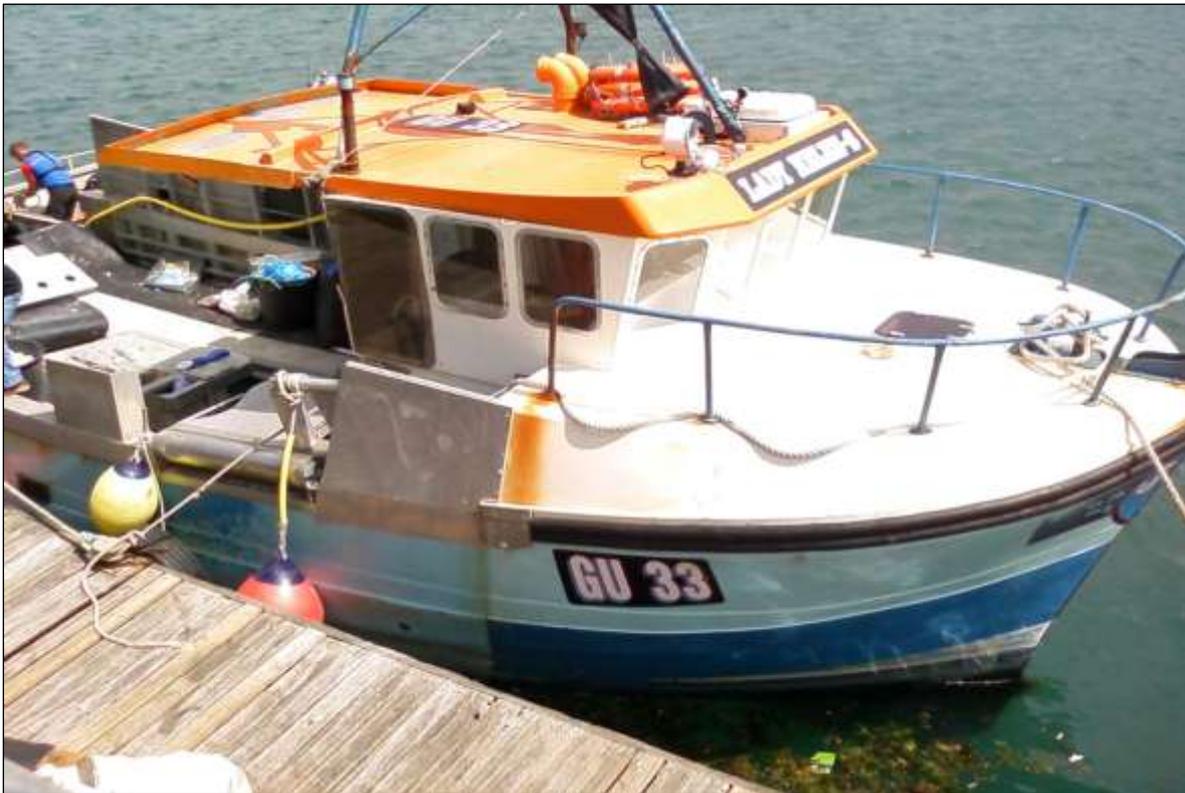
Figure 1: Fishing vessel Lady Helen- S

The explosion lifted the wheelhouse and accommodation floors, blew out the back of the wheelhouse and some of the windows, blew out a bulkhead hatch and blew the vivier hatch off its hatchway.

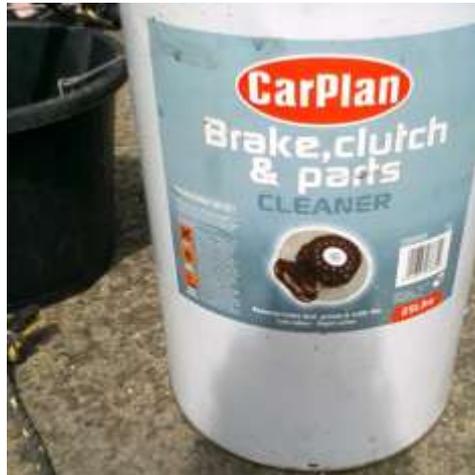
Figure 2: CarPlan Brake Cleaner

The engine room hatch was closed causing insufficient ventilation/gas freeing of the space. Due to residual vapour from the Brake Cleaner in the engine room space, an explosion occurred when the main engine was started due to a spark being generated in the contactor solenoid or motor brushes. Fortunately no liquid was left in the space to cause conflagration to accompany the explosion.

1. The explosion occurred as a result of vapour from the cleaner igniting when the engine was started.
2. The safety Data Sheets for this product gives it UN No 1993, Hazard Class 3, Flammable Liquid, with it also being an environmentally Hazardous Substance / Toxic Marine Pollutant.

3. This product is totally unsuitable for use on a fishing vessel, particularly in the confined spaces of an engine room.
4. Safety Data Sheets and user instructions should be available for all products in use on board and careful consideration should be given for their appropriate use.

5. The ensuing explosion could have been avoided if the skipper had allowed adequate time for ventilating the engine space.
6. Unfortunately the young crew member took it upon himself to “use his initiative”.

7. Young or inexperienced crew members need to be supervised by an appropriately trained member of the crew.
8. Even the most mundane tasks, if not approached in the correct way can, either through inexperience or thoughtlessness, lead to potentially serious or fatal consequences.
