Summary report on the Investigation of  
the berthing incident  
of the High Speed Craft  
***CONDOR LIBERATION***

At St Peter Port Harbour

On 03 May 2017

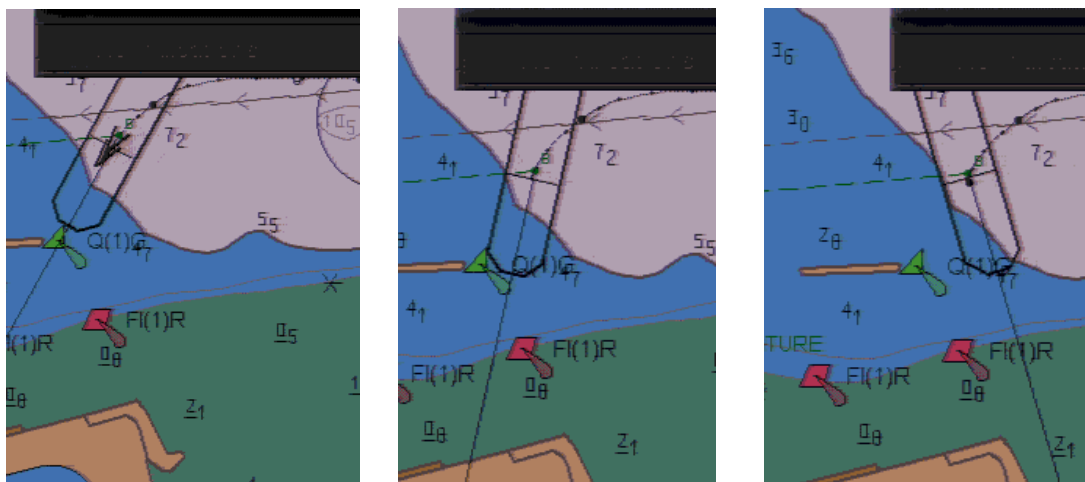
At approx. 1545 on 3<sup>rd</sup> May 2017, Condor Liberation was manoeuvring within St Peter Port harbour in order to moor at No 1 berth. The vessel made contact with the small craft pontoon in the outer pool area of the port, as well as a private sailing catamaran and the starboard hand lateral mark.

*ECDIS display of vessel turning towards pontoon and starboard hand buoy.*

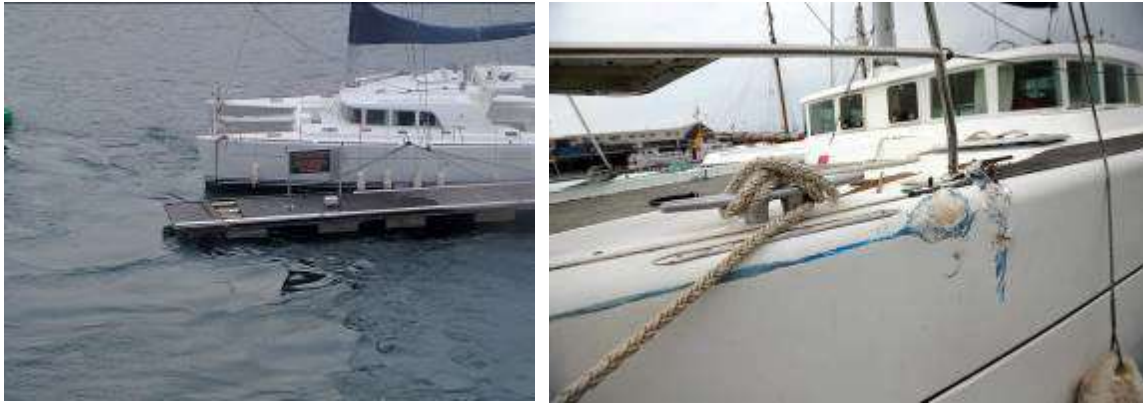
This caused damage to the pontoon and a catamaran berthed on the pontoon's south side. Condor Liberation subsequently berthed without further incident.

*Damage to sailing catamaran and pontoon.*

1. The Master undertook a review of his own notes regarding marks and identification of go/no go areas as well as contingency plans. He also conducted a period of duty with an additional master sailing in support.
2. This scenario will be added to the simulator training options.
3. Additional training for crew members who report distances to the bridge will be provided.
4. The company will review the position of navigational aids on each bridge wing.
5. The recommendations from the company response will be held on file for lessons that could be relevant to any new tonnage, either new build or purchase.
