# Annual Report For The Chief Inspector Of Marine Accidents – Bailiwick of Guernsey 2020

Issue Date                    31/08/2021  
Document Owner            Harbourmaster, Guernsey

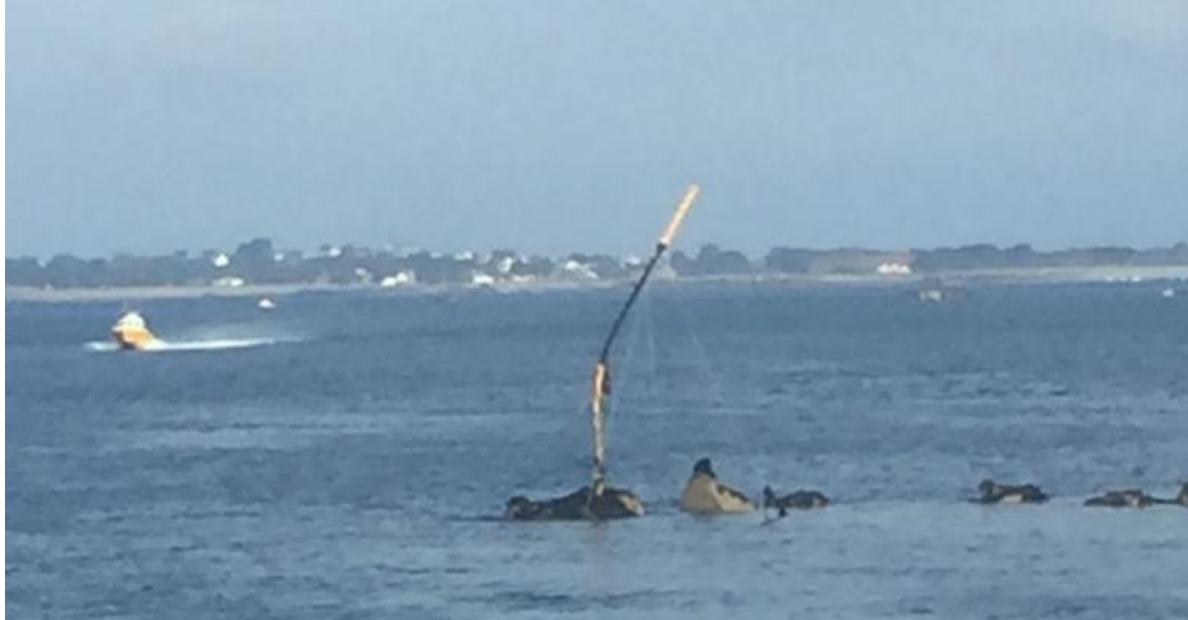
## 4.2. Stinger RIB in collision with 'Gate Rock' Westerly Cardinal Beacon on Saturday 24 August 2019

At approximately 21:30 BST on Saturday 24th August 2019, a Stinger RIB with 7 persons onboard was returning from Sark to Guernsey via the Percee passage to the south-east of Herm. At this time, it appears that the vessel collided with the 'Gate Rock' westerly cardinal beacon at some speed (approximately 25kts according to the Skipper).

As a result of the collision one passenger was seriously injured and the RIB badly damaged. 'Gate Rock' beacon was also very badly damaged, and Navigation-Warnings were issued once the extent of that damage was ascertained from the late, Travel Trident vessel returning from Herm.

Very shortly after an ambulance crew arrived to treat the casualty for his injuries. As lights were turned on to assist the ambulance crew in seeing the extent of the casualty's injuries, severe damage to the Starboard quarter of the vessel, which was significant, was noted.

The RIB had been travelling in a north-westerly direction at approximately 25kts when due to poor navigation, spatial disorientation (possibly due to alcohol consumption) and very dark conditions at the time, it passed to the north – east of the beacon, between the wire stay and the beacon pole.

The wire stay dragged down the starboard side of the vessel leaving the marks on its buoyancy collar before striking the passenger who was standing behind the helm seat causing the severe injuries previously noted.

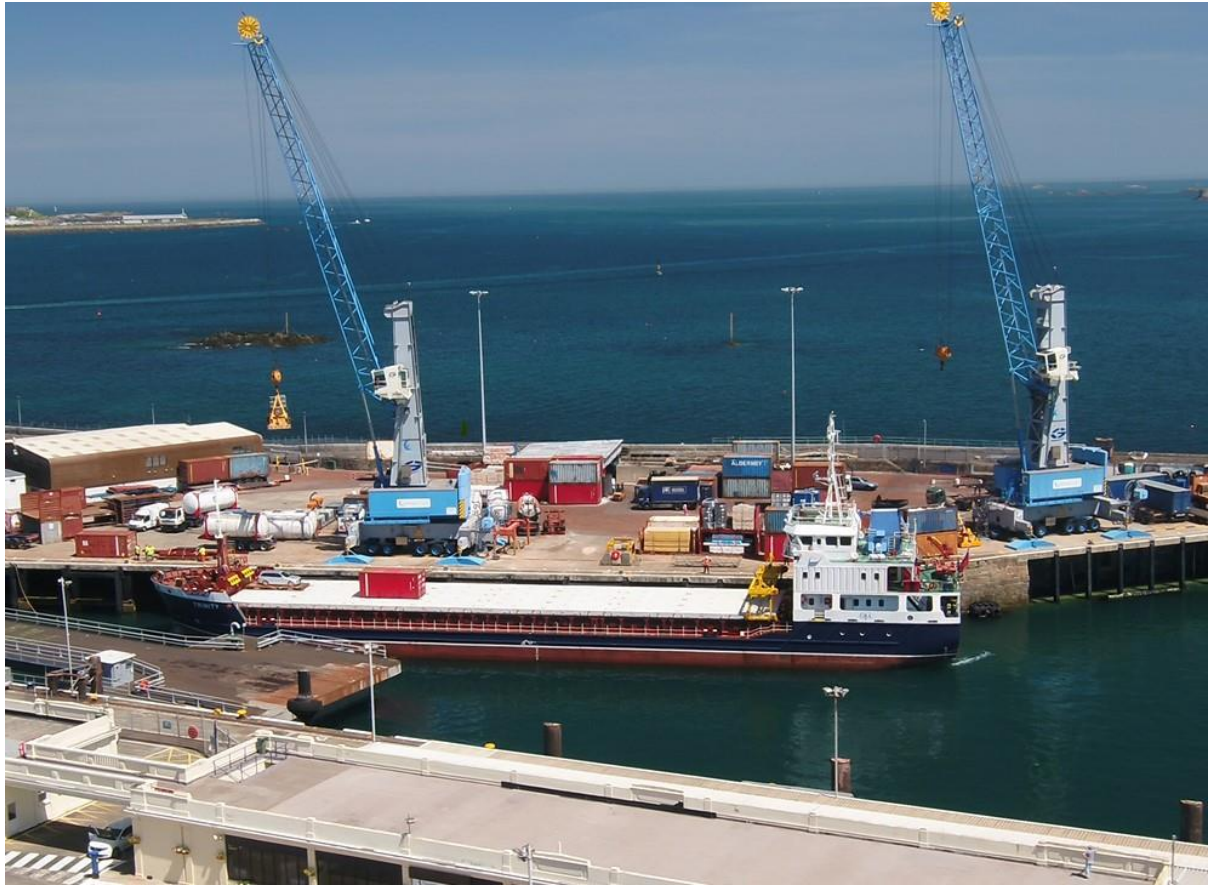
### 4.3. M/V Trinity Berthing Incident - 06 November 2020

The fishing vessel New Dawn called Guernsey VTS to offer assistance if required, this offer was accepted by Guernsey VTS as by this time, M/V Trinity was bow onto No 5 berth with her Port quarter resting on the Port shoulder of the M/V Commodore Goodwill.

At 06:10 M/V Trinity requested assistance and fishing vessel New Dawn was able to pass a line in order to stabilize the situation and to attempt to pull M/V Trinity off of M/V Commodore Goodwill. At the same time the DHM arrived on scene after being called in from home.

During the course of the subsequent investigation it was noted that M/V Trinity had particularly poor handling characteristics as attested to by the four local General Pilots.

Guernsey Harbours and Faversham Ships (M/V Trinity owners), placed maximum weather restrictions on the vessel and Guernsey Harbours put in place Standard Operating Procedures (SOP's) for the use of Sarnia in assisting vessels during berthing operations.

Faversham Ships improved the handling characteristics of M/V Trinity by making adjustments to her Controllable, Pitch Propeller (CPP) and its associated control system and also improved the effectiveness of her bow thruster.

At the request of Guernsey Harbours, Faversham Ships have also drafted full risk assessments for berthing in St Peter Port Harbour.
