Report on the Investigation of
the grounding
of the passenger ferry
Trident V

In the Alligande Passage, approaches to Herm Island

On 08 June 2016

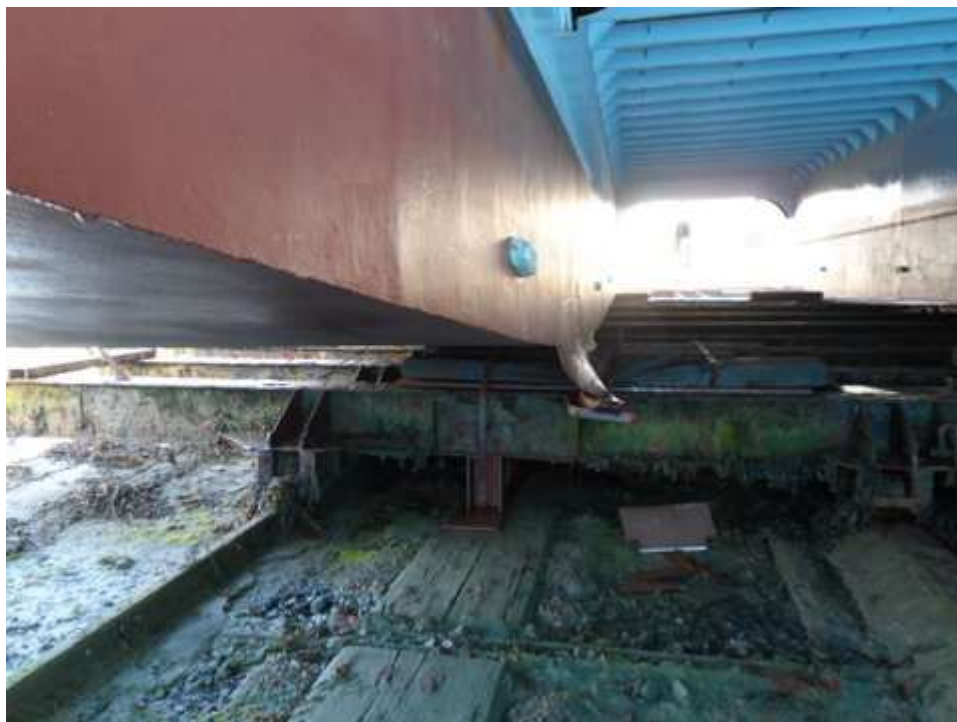
The skeg of the port hull was distorted. **(Figure 1)**

Figure 1: Distortion to port skeg

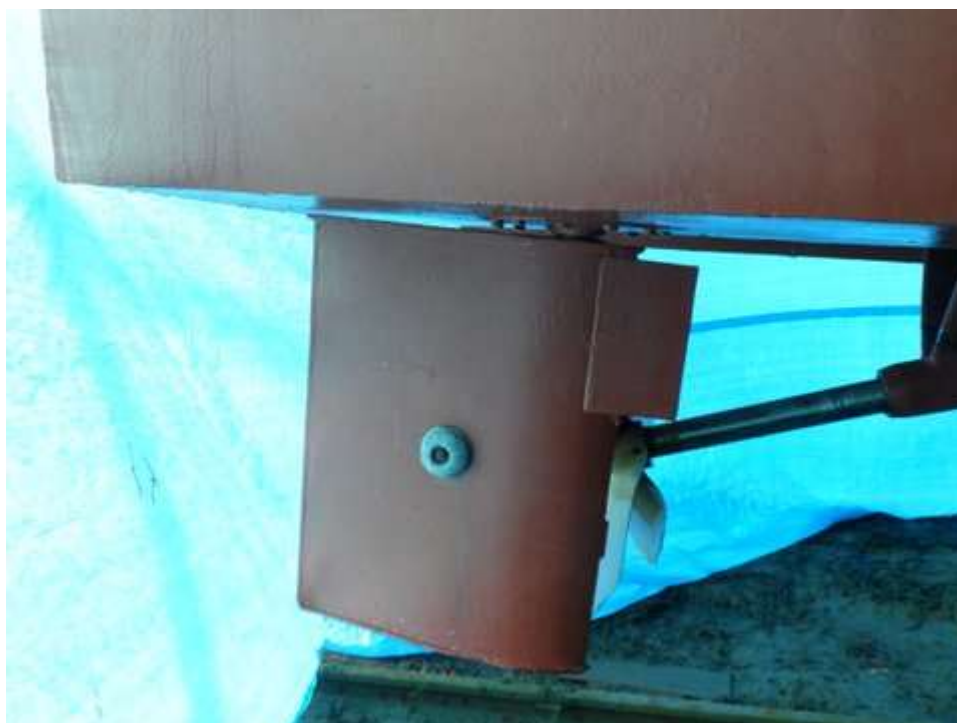
The port rudder was distorted out of position with contact damage to the rudder itself. **(Figure 2)**

Figure 2: Port rudder distorted out of position

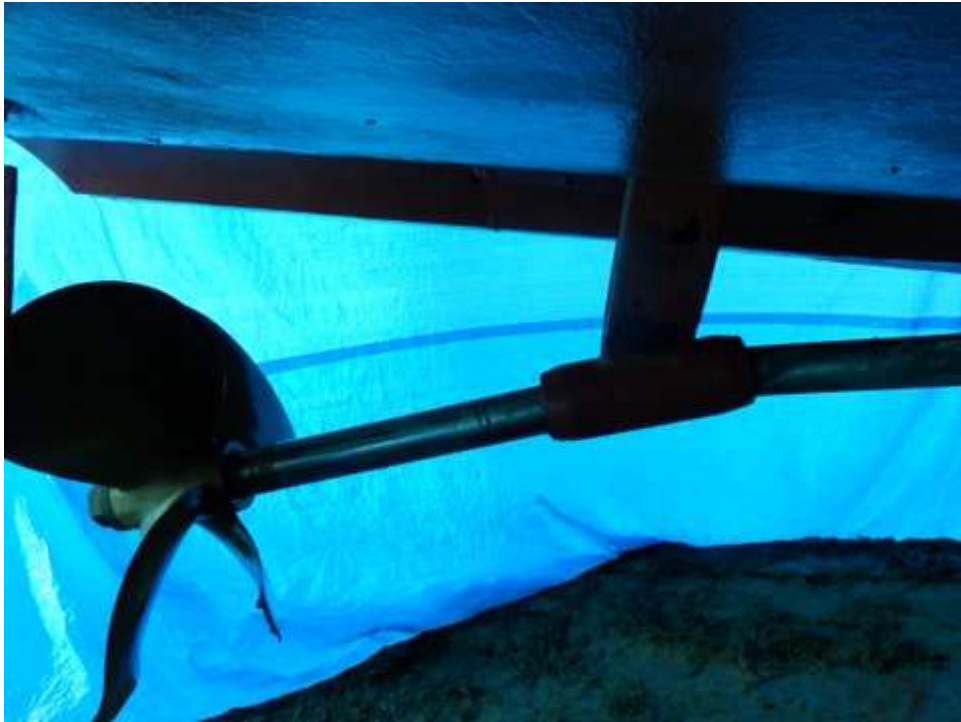
The port propeller blades were distorted. **(Figure 3)**

Figure 3: Port propeller blades distorted

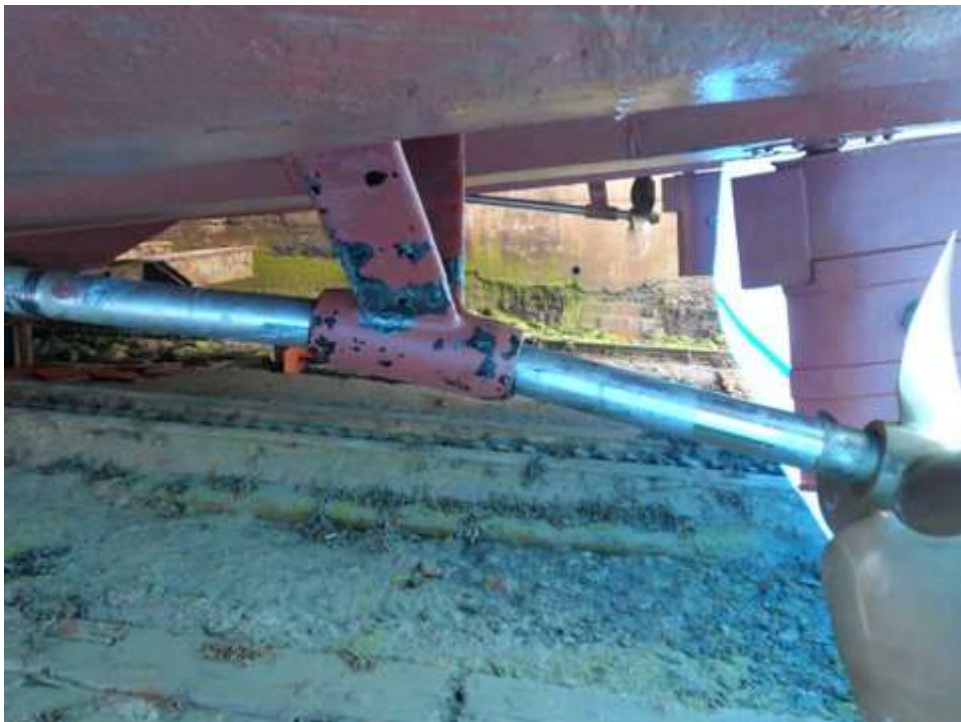
The port shaft and 'P' bracket were distorted with contact damage. **(Figure 4)**

Figure 4: Port shaft and 'P' bracket distorted

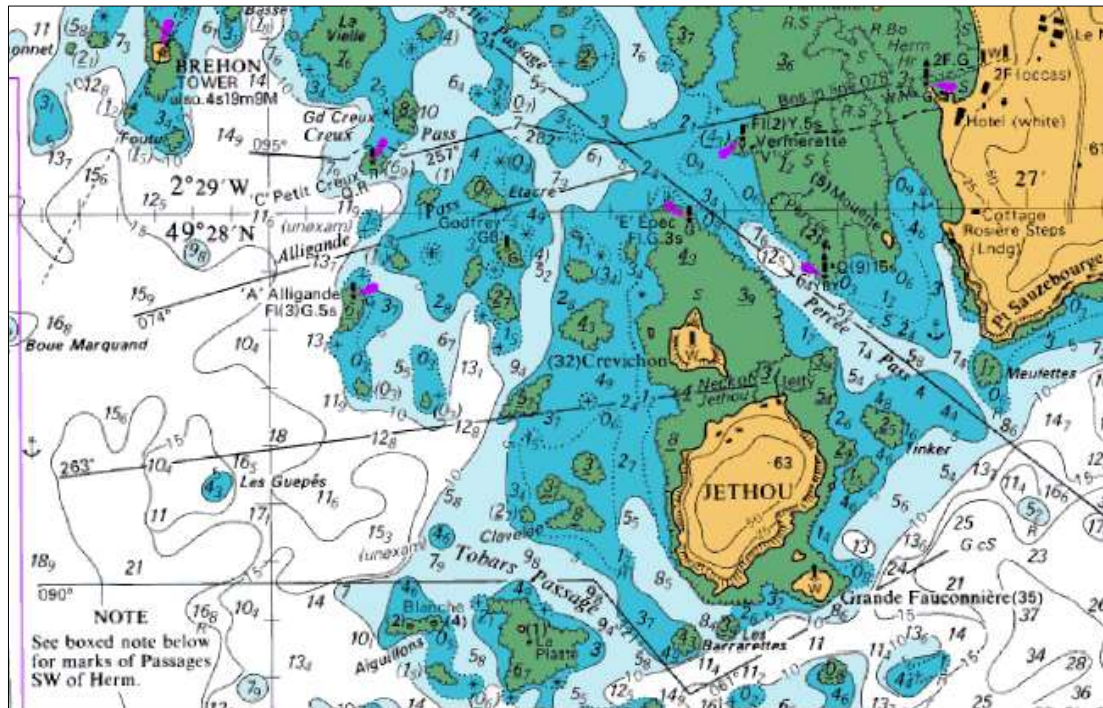
Figure 5: Admiralty chart extract of Alligande Passage

It is clear that the charted 074° track passes close to a number of hazards both to the north and south, and strict track control is required. The visual transit to maintain the track is Vermerette Beacon in line with Herm harbour pierhead white patch. This is followed until either the Percee passage track is adopted or the approach into Herm harbour, depending on the height of tide.

The absence of leading transit marks due to restricted visibility meant that it was not possible to visually monitor the vessels position and that it was vital that radar navigational techniques were employed to ensure strict monitoring of the vessels position in relation to the hazards.

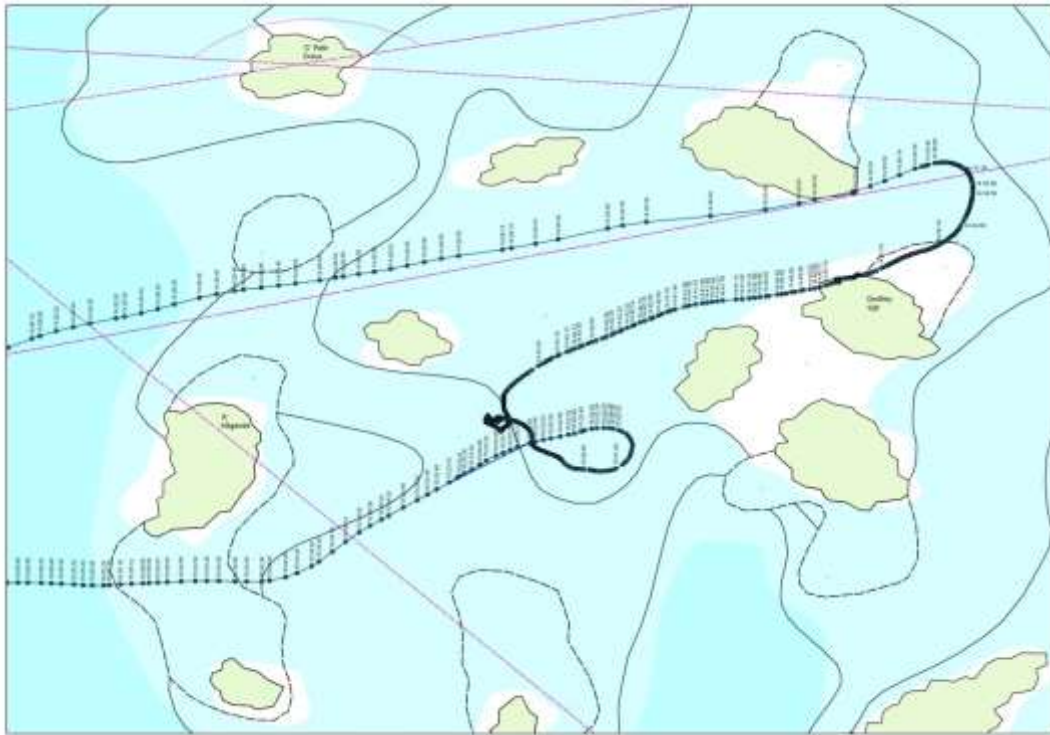
Figures 6 & 7 show the AIS track of time and COG taken by the vessel. It also shows the charted 074° track (magenta). In the approach to the grounding, *Trident V* was always to the north of the approved track.

Figure 6: AIS data showing vessel position and time

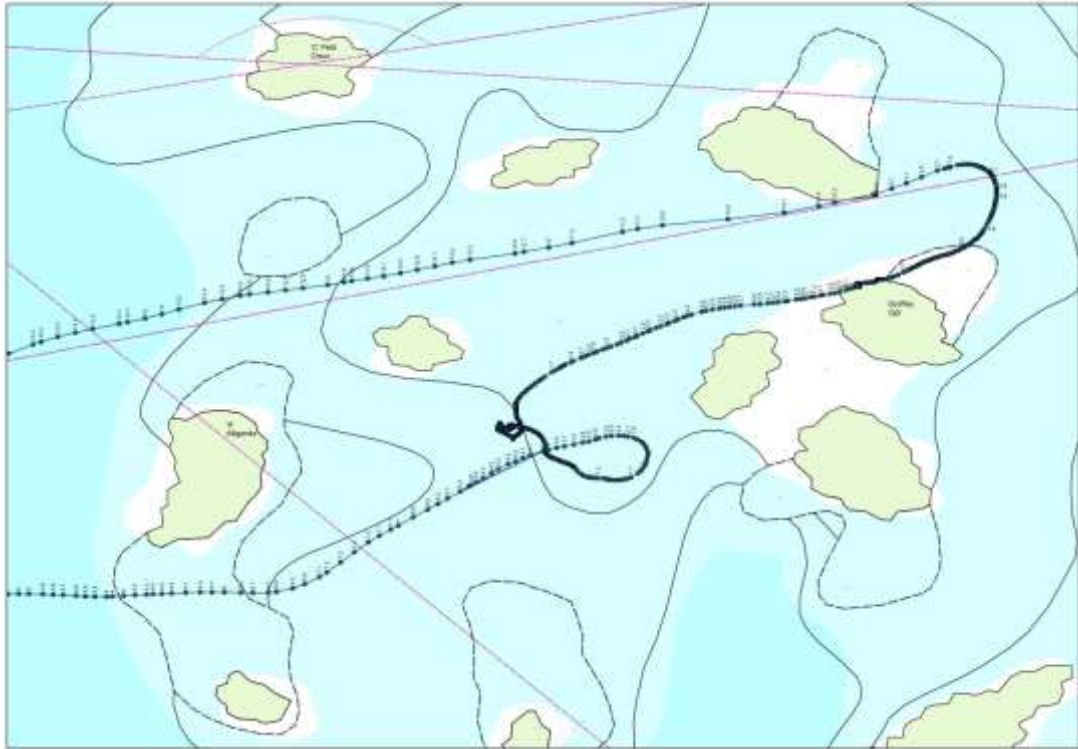
Figure 7: AIS data showing vessel position and COG
